FIRE RISK ASSESSMENT - Specialised Housing (Independent Living) (v4. August 2017)

Scheme Name **Alexandra Court**

Court Address **31 South Parade, SOUTHSEA**

Date of Fire Risk Assessment **16/07/2024**

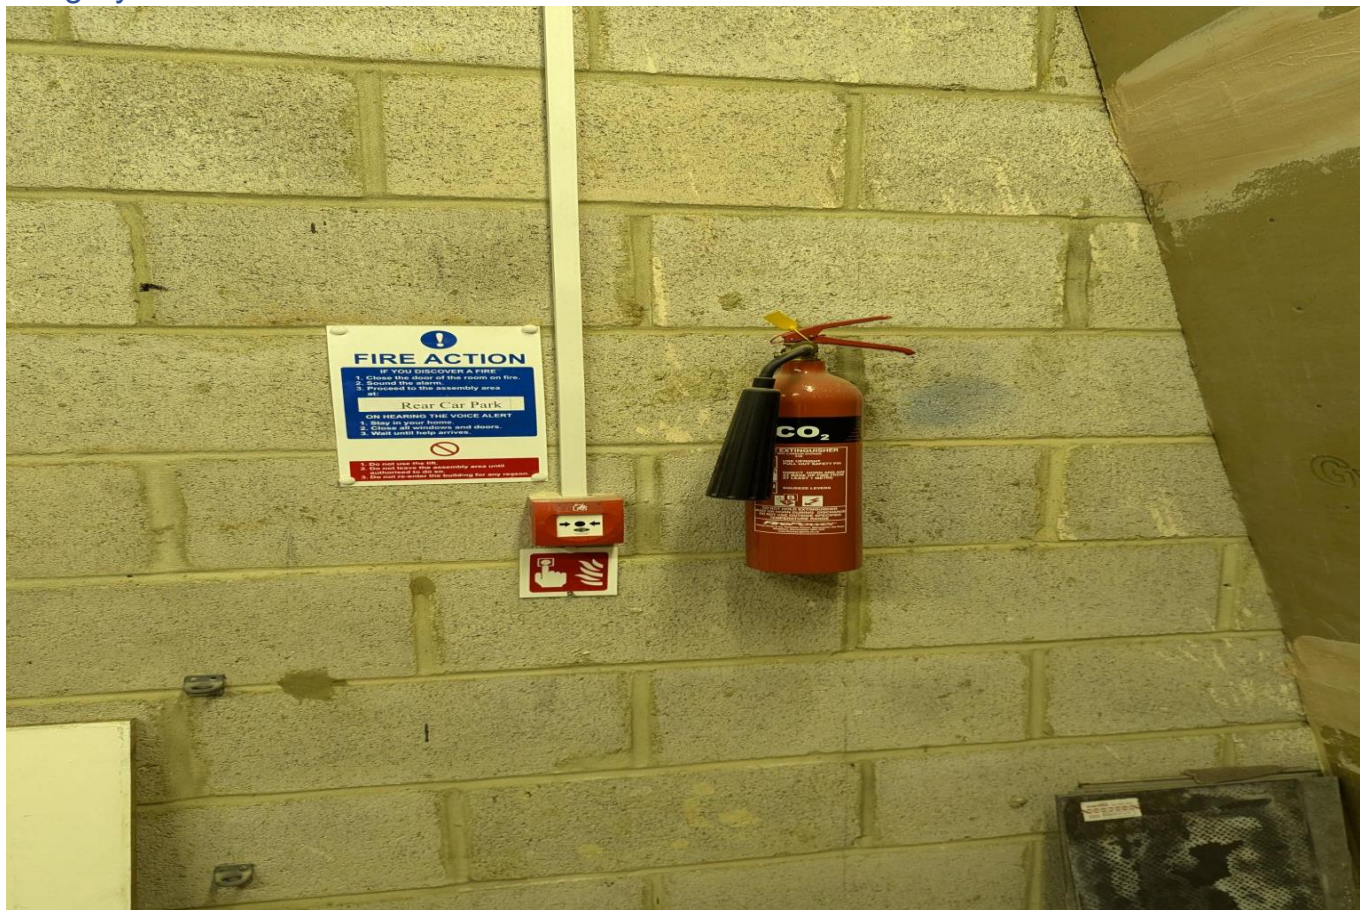
The old dry risers have now been charged with water following on from the Category 2 sprinkler installation. When the next round of extinguishers replacements are due, ensure the CO2 extinguisher located in the upper floor plant room is replaced.

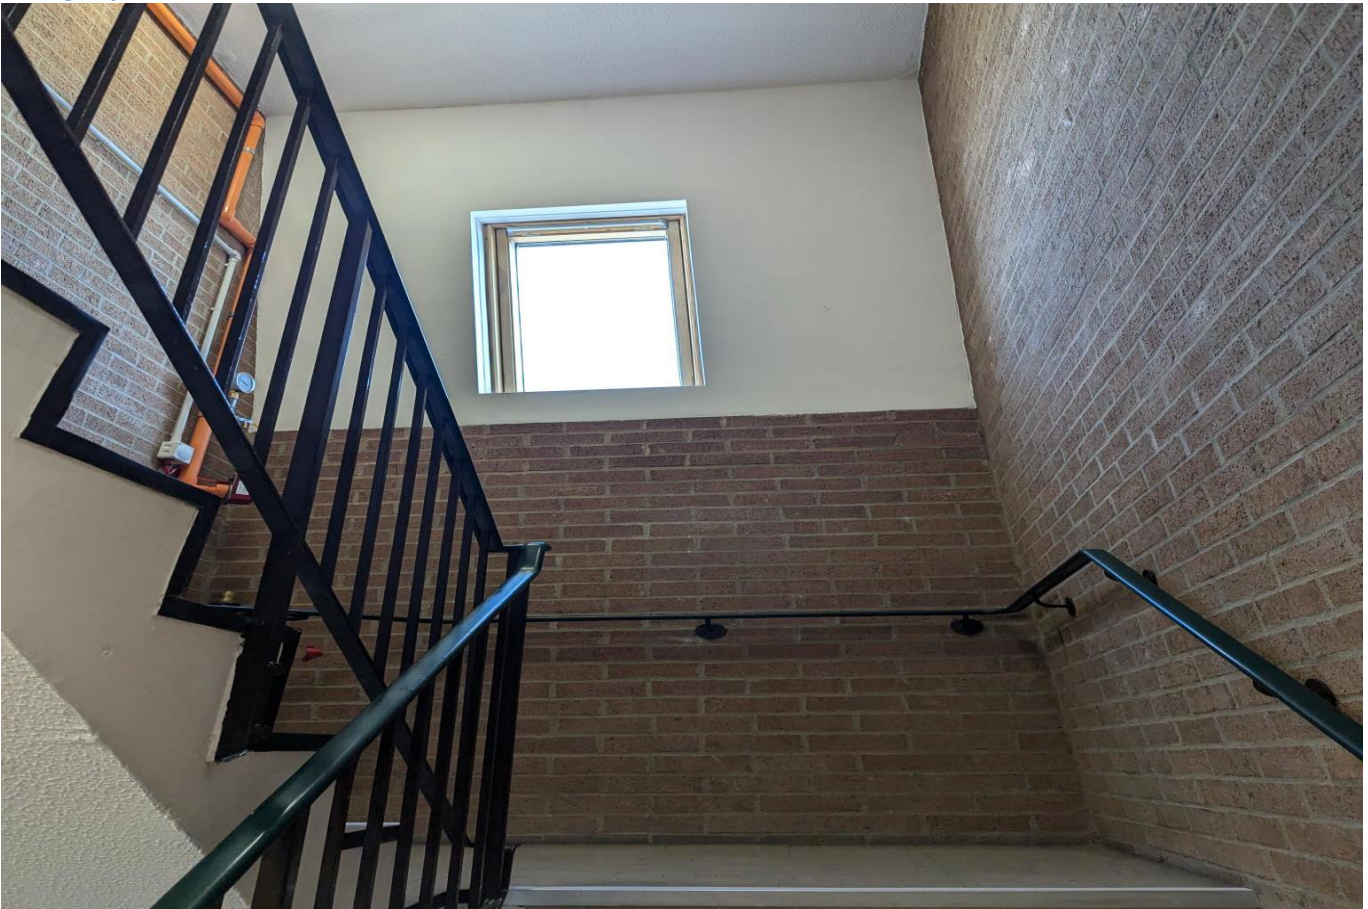
The previous dry risers are now charged with water to facilitate the sprinkler system. The Velux window in the top of the stairwell should be an AOV type and configured to open in the event of an activation. This will need to be extended to integrate into the AOV onsite. In addition the AOV's should open on the floor of activation and will need re programming to suit this requirement.

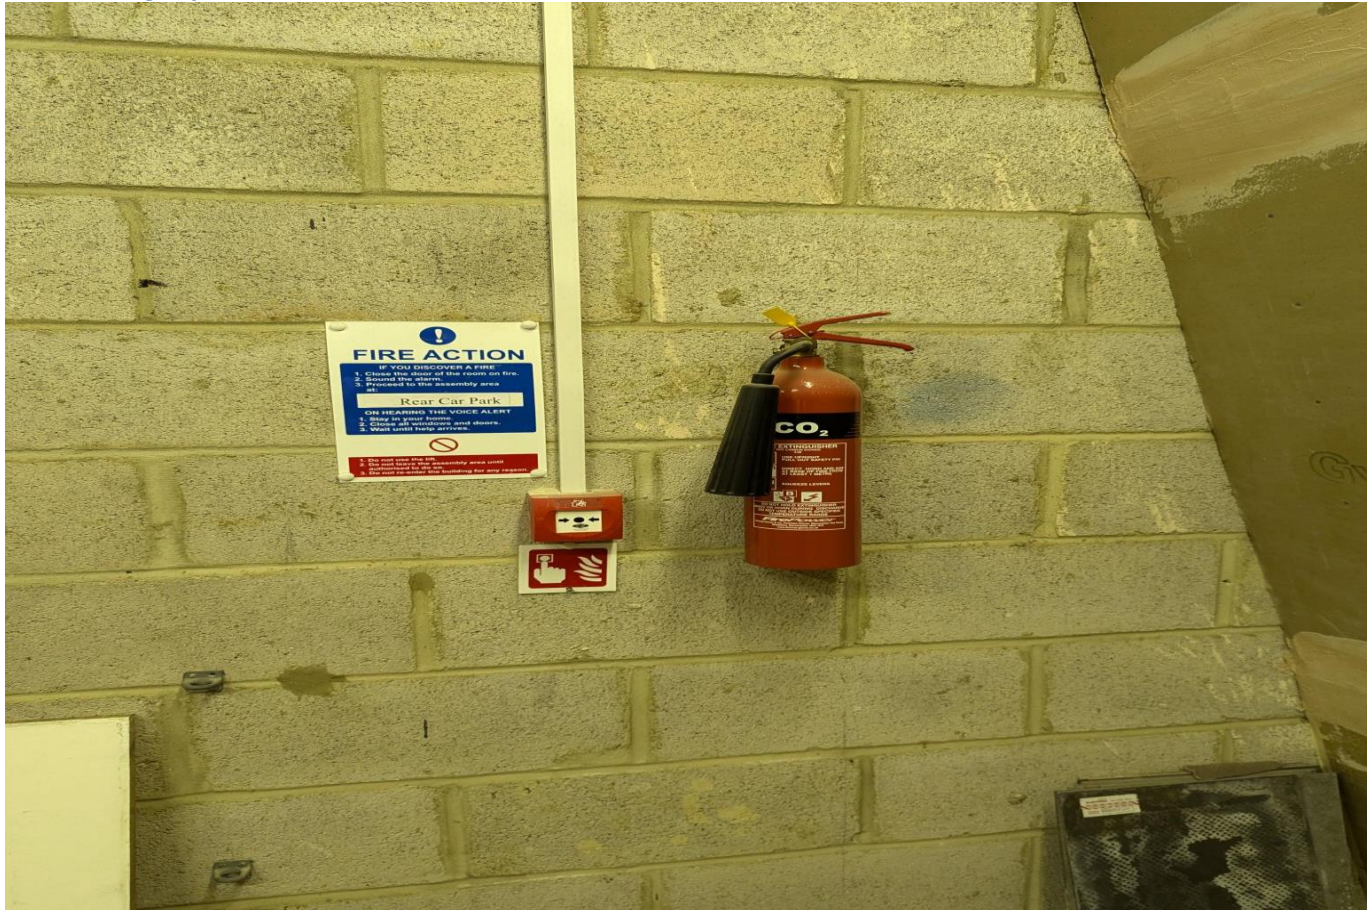
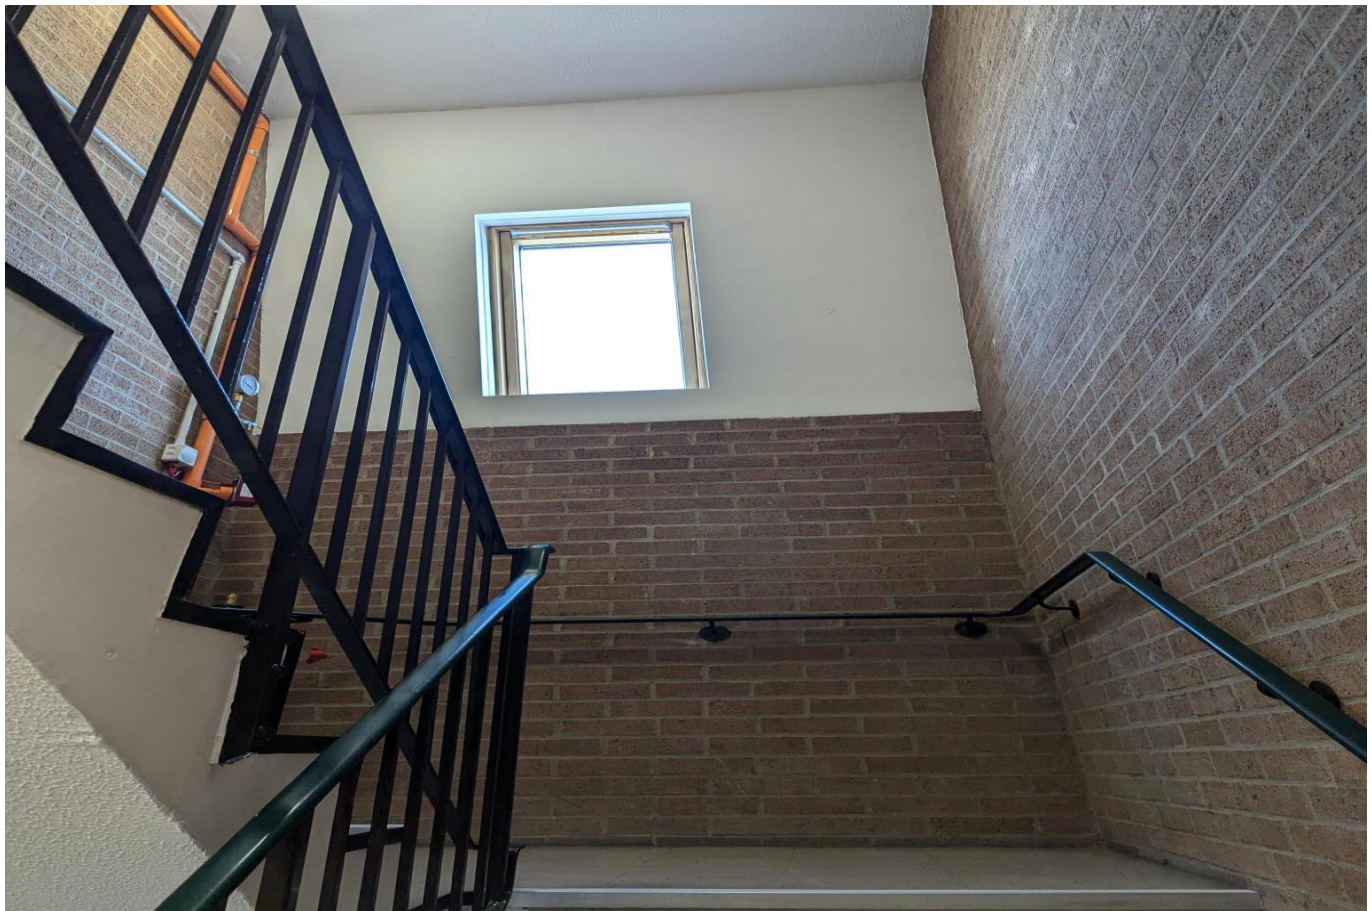
Risk Imagery

Risk ID	Risk Level	Risk Owner	Comments	Deadline
Risk ID-4833	Low	Court Manager	The cleaners cupboard requires a sign on the outside of the door	17/01/2026
Risk ID-4841	Medium	Court Manager	A detector is required in the bin store	19/07/2024
Risk ID-4842	Medium	Court Manager	Complete door remedials listed in section 8	17/07/2025
Risk ID-4849	Observation Only	Surveyor	When the next round of extinguishers replacements are due, ensure the CO2 extinguisher located in the upper floor plant room is replaced.	
Risk ID-4850	Medium	Surveyor	The Velux window in the top of the stairwell should be an AOV type and configured to open in the event of an activation. This will need to be extended to integrate into the AOV onsite. In addition the AOV's should open on the floor of activation and will need re programming to suit this requirement.	19/07/2025
Risk ID-4848	Medium	Surveyor	The communal extraction system is due to be replaced this year. Works started but the contractor retracted from the works once 30% through due to financial difficulties. Both the area based surveyor and Property Services Manager are	31/07/2024
